A somewhat different kneewall repair

- Owner: CamperAndy
- Titanium 29E34RL
- Built in May 2001
- Glendale frame
- Atwood AB-72 pinbox
- Gooseneck & kneewall work done in October 2014

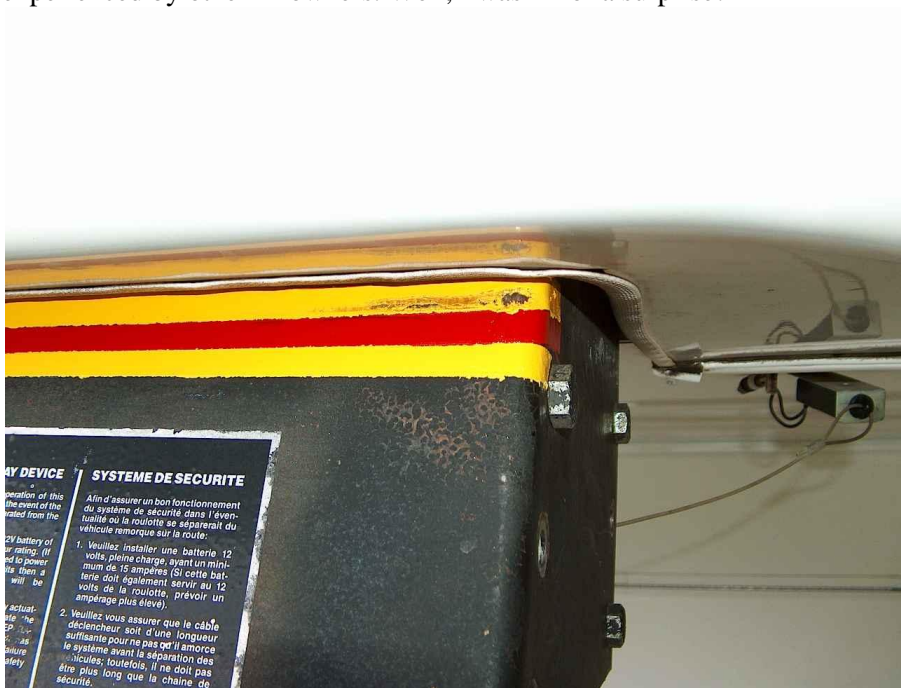
Beginning of ownership: half an inch deflection.

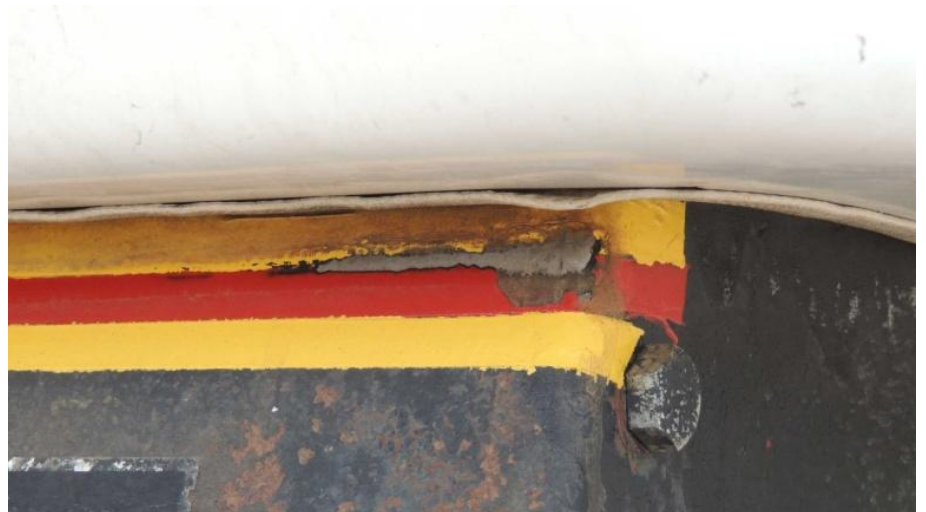
After a few years of ownership and about 30'000 km/19'000 miles made by myself with this trailer, the pinbox deflection went from about 12 mm/half an inch static to 25 mm/1 inch static and a bit more dynamic (when driving down the highway).

Before the repair: one inch deflection.

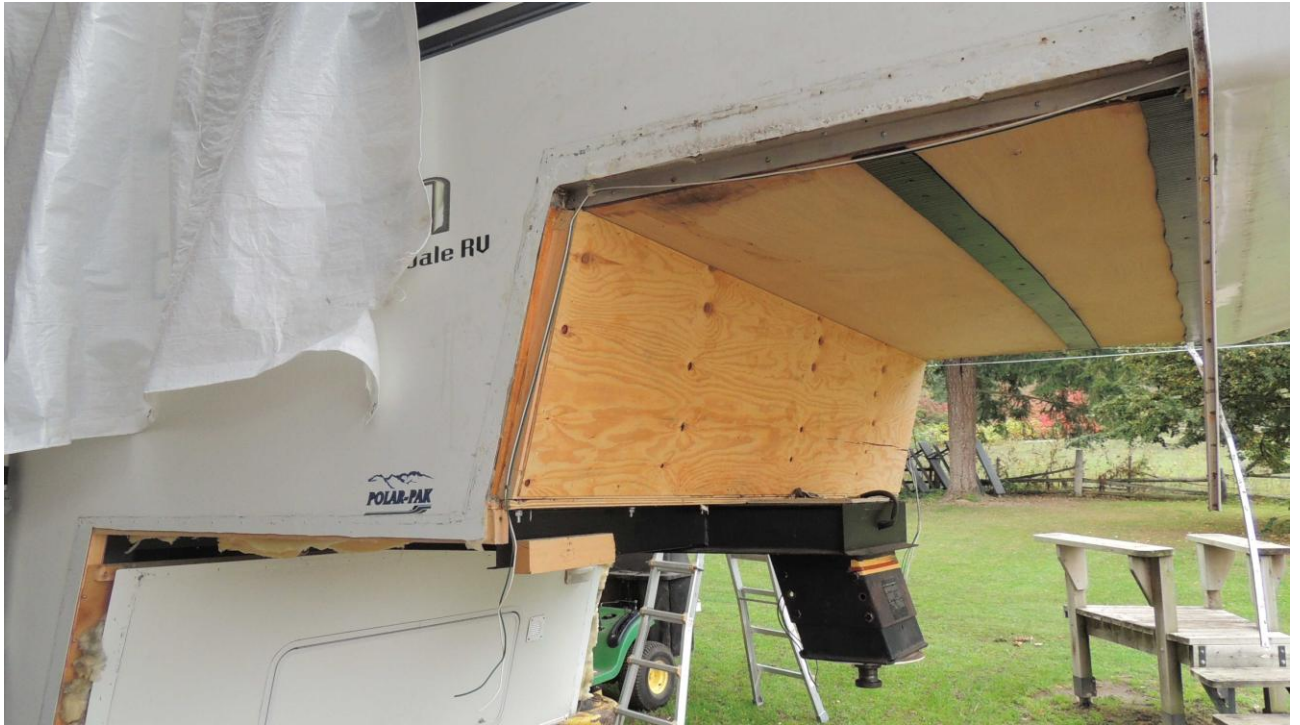
And then a big surprise: Absolutely no damage at the kneewall! No sheared of screws, everything is still intact at the kneewall-sidewall connection. The metal gooseneck construction had enough play not to damage anything above the pinbox.

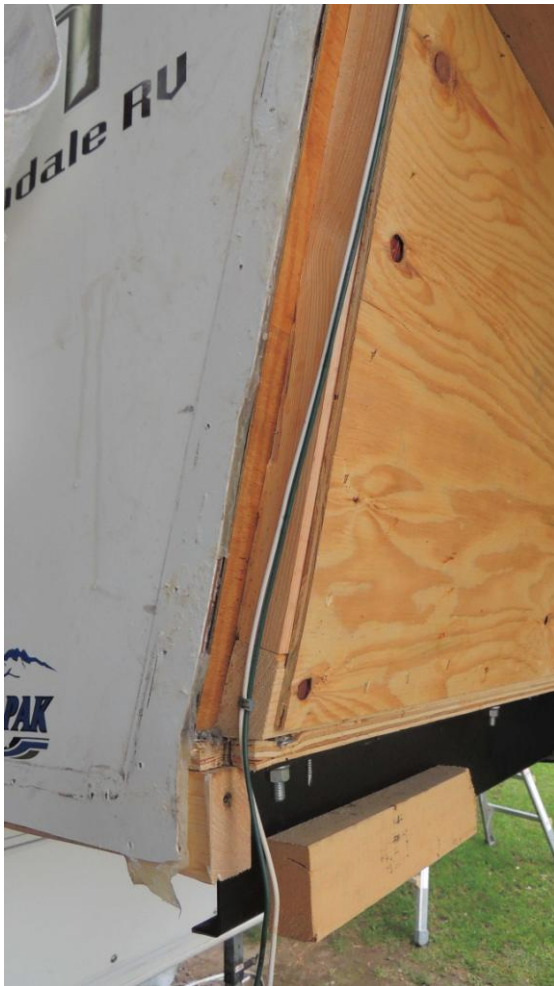
Right side kneewall-sidewall.

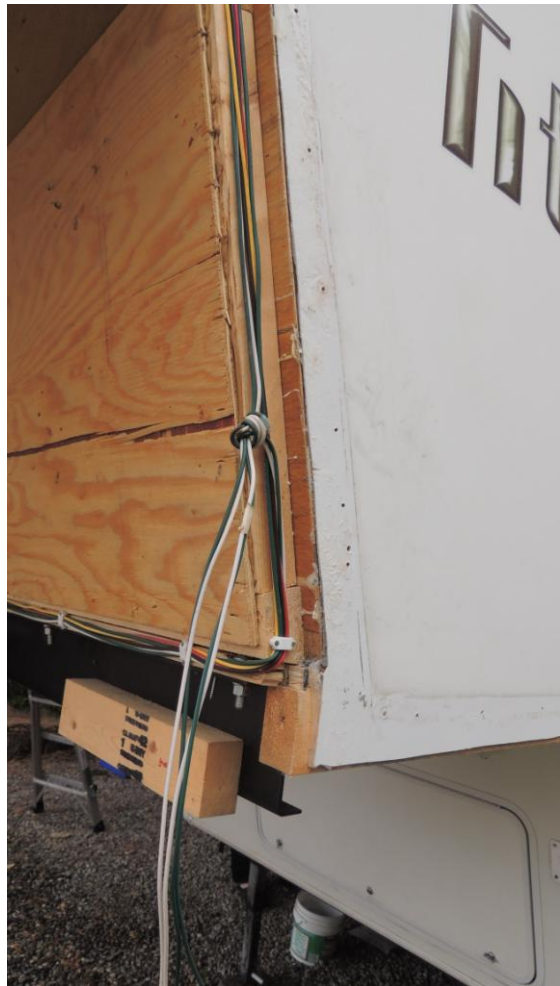
Left side kneewall-sidewall.

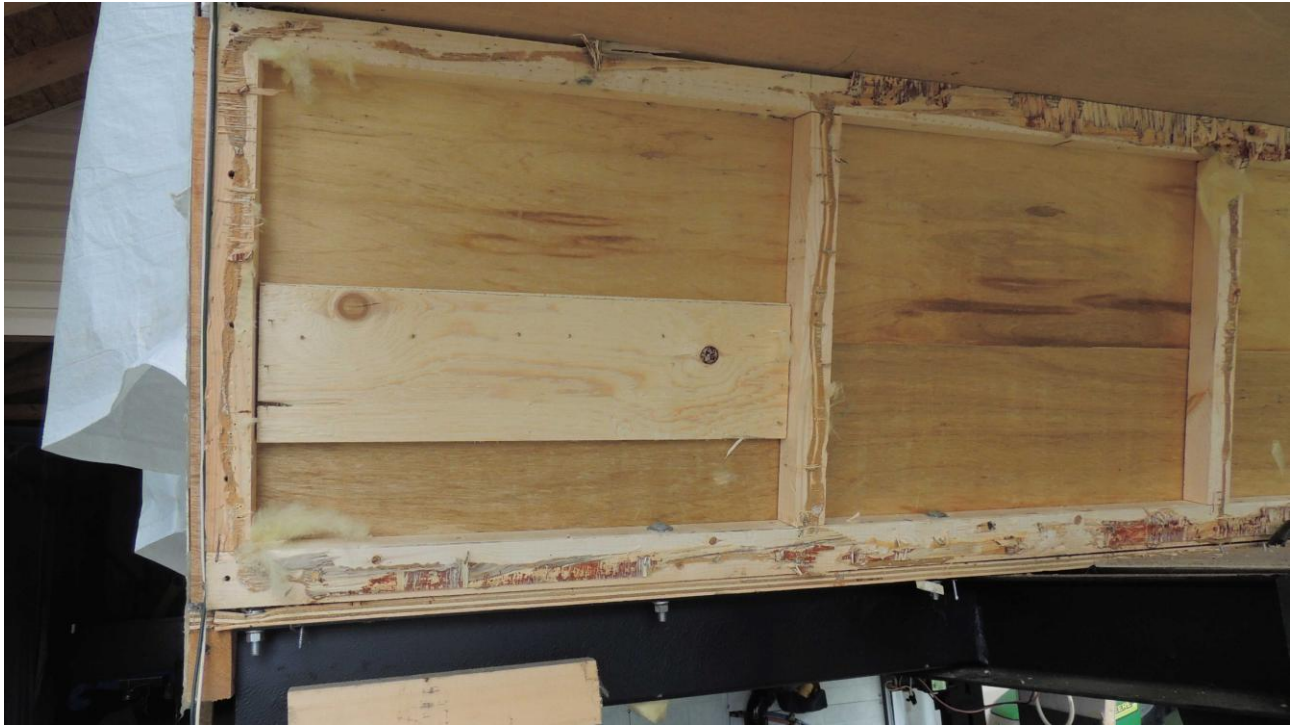
Passenger's side kneewall, after removing the front plywood, no damage at all.

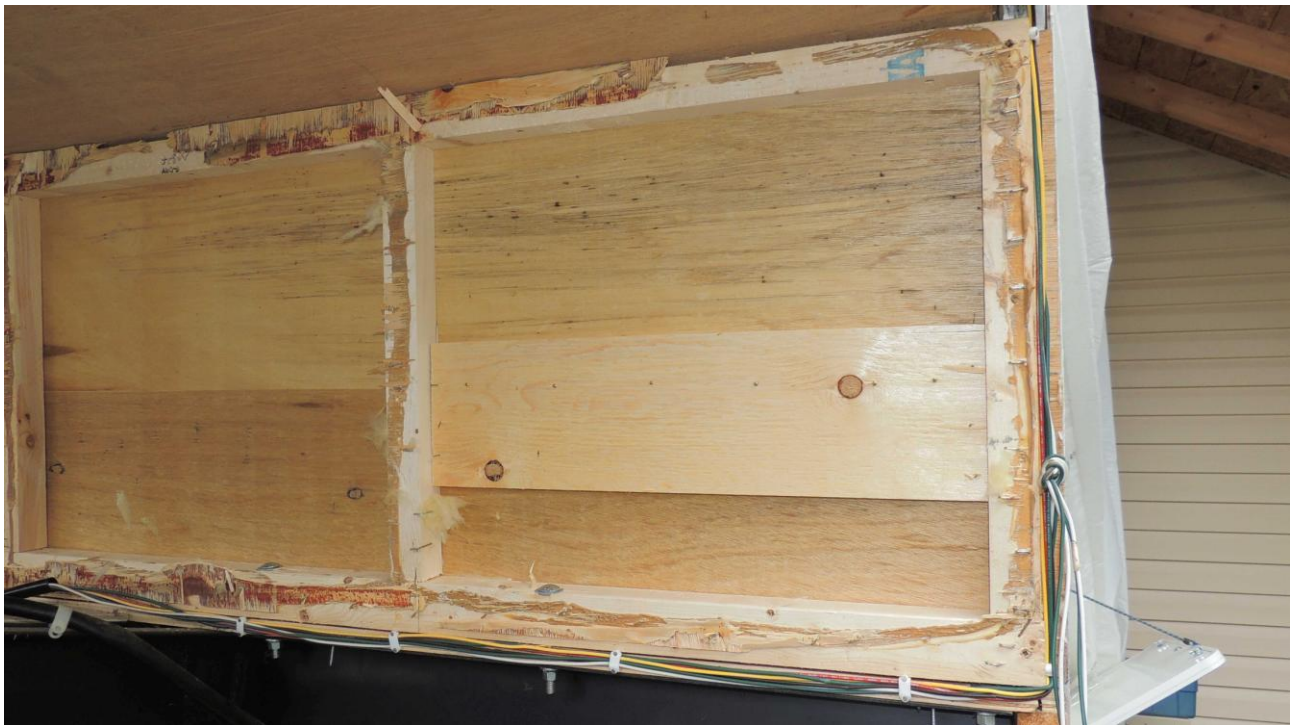
Driver's side kneewall, after removing the front plywood, no damage at all.

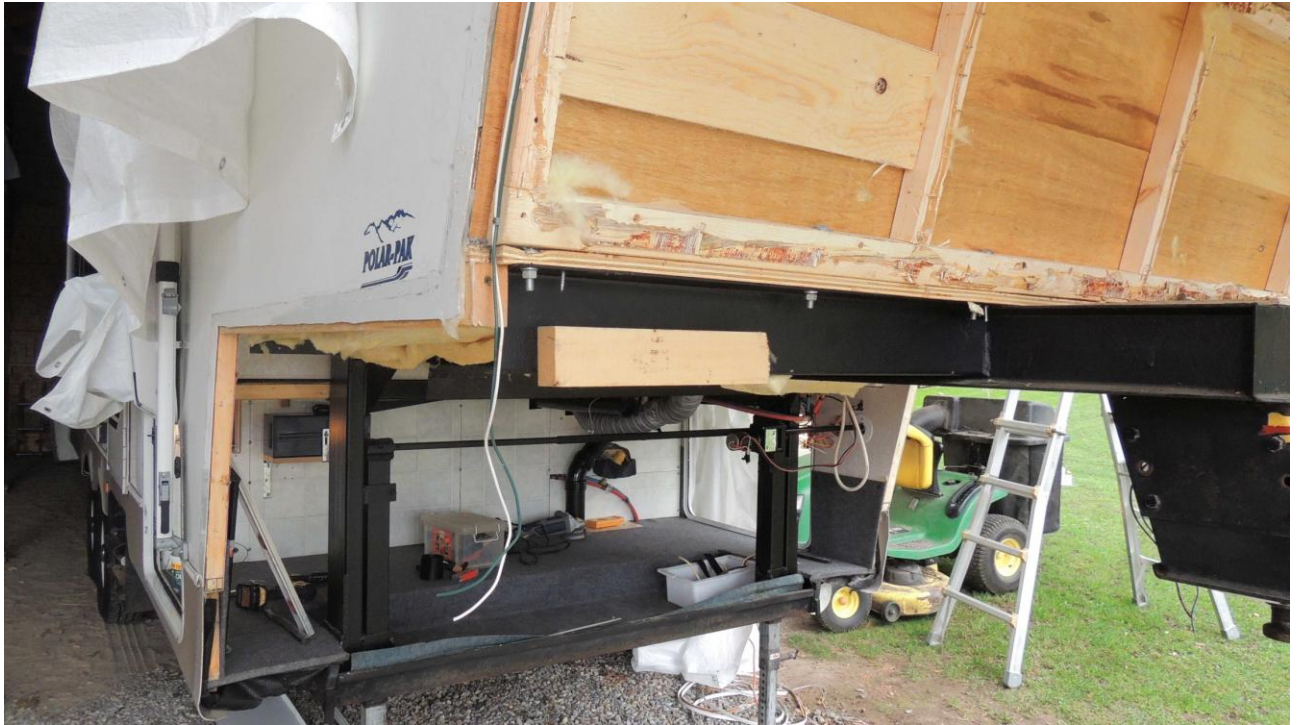
Off comes the front basement wall and the top gooseneck elbow gets a thorough inspection – and the bottom one too. However, all the welds are still good. I have to assume that the whole deflection comes from a weak gooseneck construction.
